Manhole Inspection Summary

Manhole # S69G1_002MH

Insp Date: **2/15/08 11:46 AM**

Location Address: **2600 Ralls Ave.**

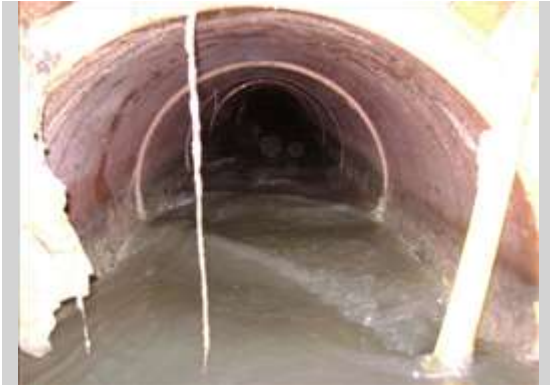
12 O'Clock Outflow

27 in. Circular Gravity Sewer
Pipe Out @ 12 O'Clock

Deposits: ☐ None ☐ Mud ☐ Sludge ☐ Debris ☒ **Grease**

Silt Depth: **0.125** (in.) Deposits Extent: **Light**

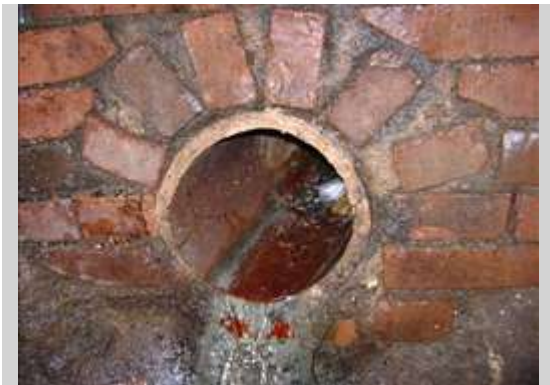
3 O'Clock Inflow

8 in. Circular Gravity Sewer
Pipe In @ 3 O'Clock

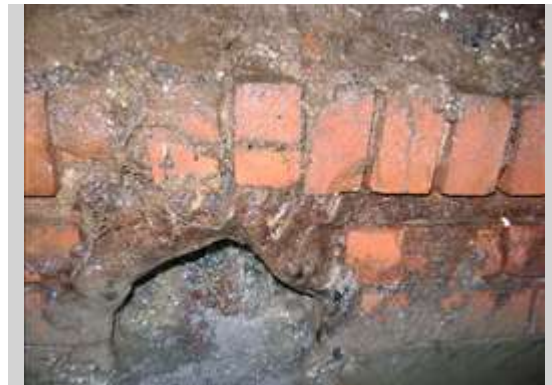
Drop In @ 3 O'Clock

Drop: **Inside**

Drop Condition: **Open**

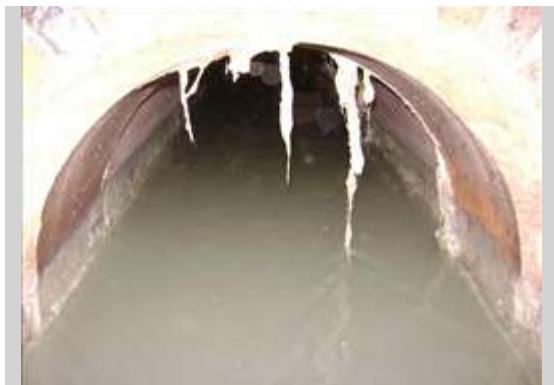
6 O'Clock Inflow

27 in. Circular Gravity Sewer
Pipe In @ 6 O'Clock

Deposits: ☐ None ☐ Mud ☐ Sludge ☐ Debris ☒ **Grease**

Silt Depth: **0.125** (in.) Deposits Extent: **Light**
